More Lessons “Re-Learned” from Corrosion Under Insulation

The incident – the failure of a 8 inch carbon steel, high pressure hydrocarbon line due to Corrosion Under Insulation

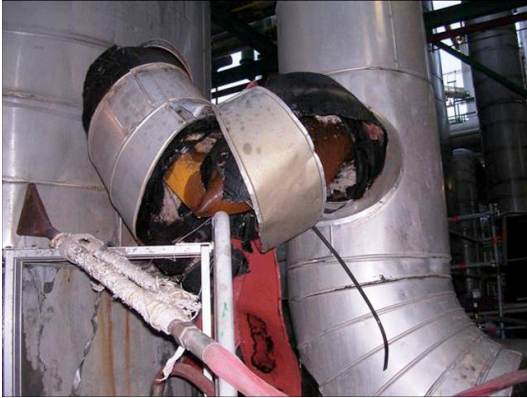
On March 13, 2008, at a Dow’s LHC plant, an 8 inch, schedule 20, carbon steel hydrocarbon line failed. The event began with a small pinhole leak, detected by the operators. While the operators were isolating and de-pressuring the line, it failed catastrophically. Fortunately, this catastrophic line failure produced such explosive force that the line bent in two locations – essentially sealing itself and avoiding a major release.

Fig. 1 - photo of the failed 8" pipe

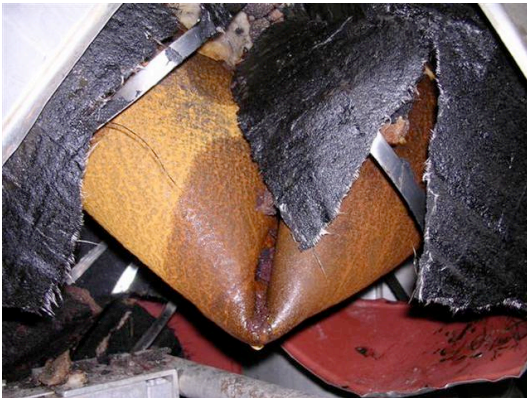
Fig. 2 – photo of the crease in pipe self-sealing the leak

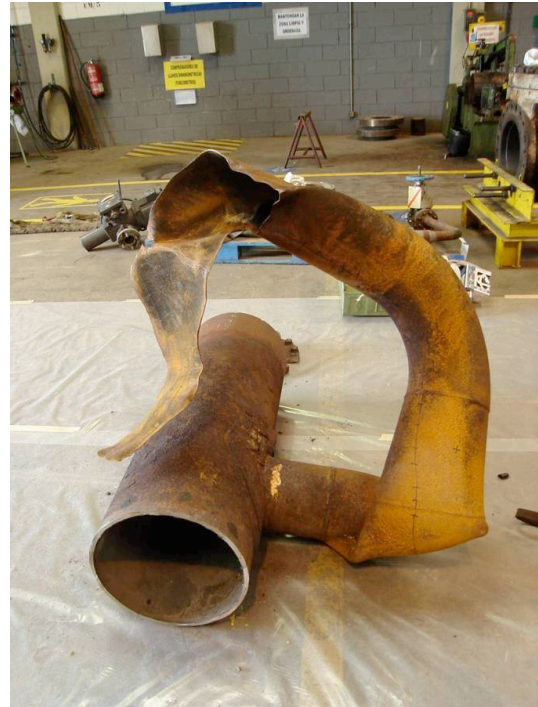
Fig 3 – photo of pipe once removed

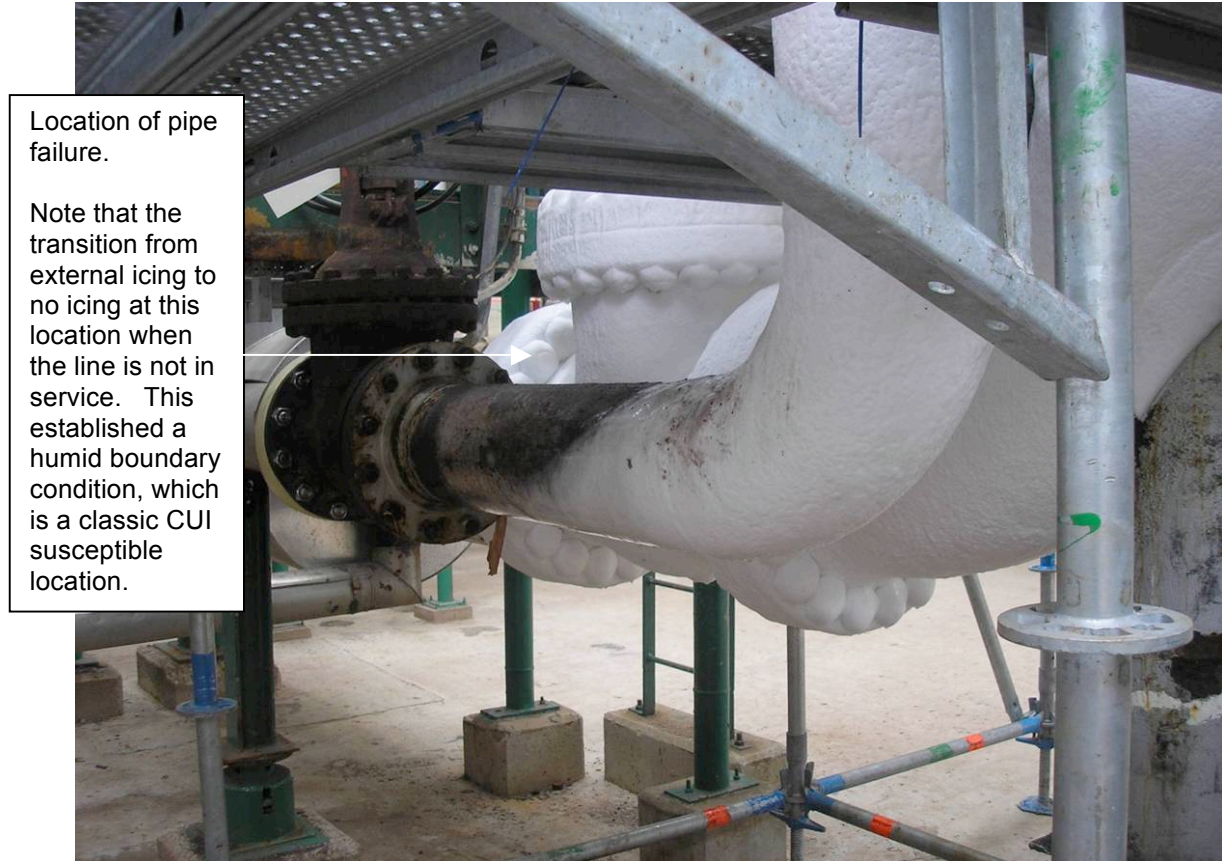
The piping was a 30 year old, schedule 20, carbon steel regeneration line to a cracked gas dryer of an ethylene plant (one of two parallel drying trains). The material in the line was non-corrosive hydrocarbon cracked gas (40% ethylene). Due to the regeneration service, the piping alternates between three different conditions, and the location of failure was where operating temperatures cause frequent or continuous condensation and re-evaporation of atmospheric moisture:

Regeneration condition (4 bar, 220° C)
On stream time: 20 days (30 bar, -17° C)
Regeneration time: 24 hrs (220° C)
Standby: 19 days (ambient temperature)

Figure 4 – photo showing installed piping when out of service
